# Manhole Inspection Summary

Manhole # S37GG\_013MH

Insp Date: **3/21/07 11:03 AM**

**Location** Address: **1331 WIRTON ST**

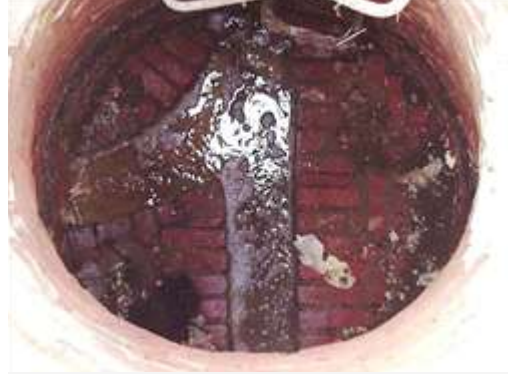
Top View

Corroded steps. Evidence of surcharge - Bench debris. Channel debris.

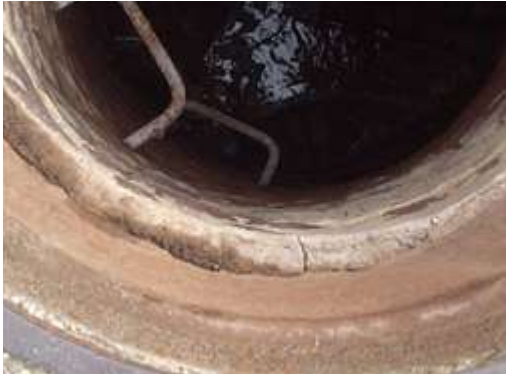
Defect

Frame leaks. Frame offset. Adjustment infiltration.

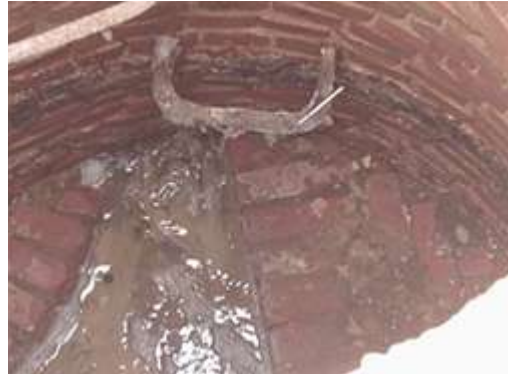
Defect

Evidence of surcharge - Bench debris. Corroded steps. Channel debris.

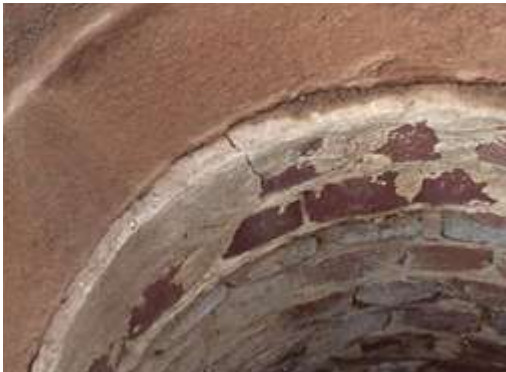
Defect

Frame leaks. Adjustment deterioration, cracks and infiltration. Corbel deterioration and infiltration.

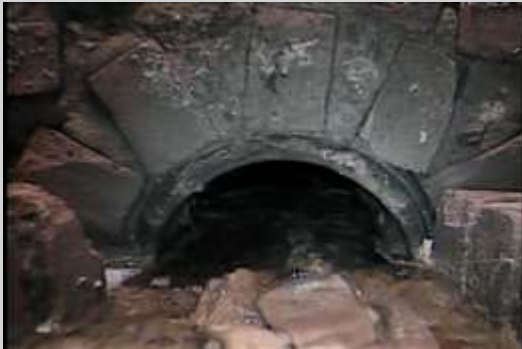
### 8 in. Circular Gravity Sewer Pipe Out @ 12 O'Clock

Barrel deterioration and infiltration. Channel deterioration and debris.

Deposits: ☐ None ☒ **Mud** ☐ Sludge ☒ **Debris** ☒ **Grease**

Silt Depth: **3** (in.) Deposits Extent: **Medium**

Infiltration: **Evidence** Pipe Seal Cond: **Unknown**

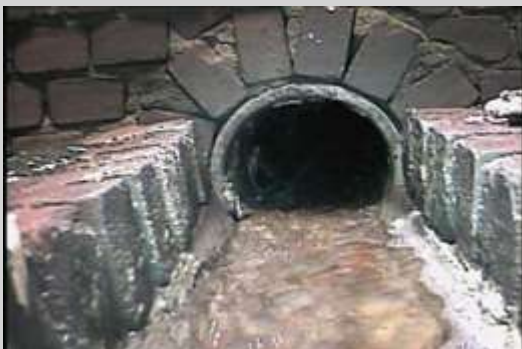
### 8 in. Circular Gravity Sewer Pipe In @ 6 O'Clock

Barrel deterioration and infiltration. Channel and Bench deterioration.

Deposits: ☐ None ☒ **Mud** ☐ Sludge ☒ **Debris** ☒ **Grease**

Infiltration: **Evidence** Pipe Seal Cond: **Unknown**

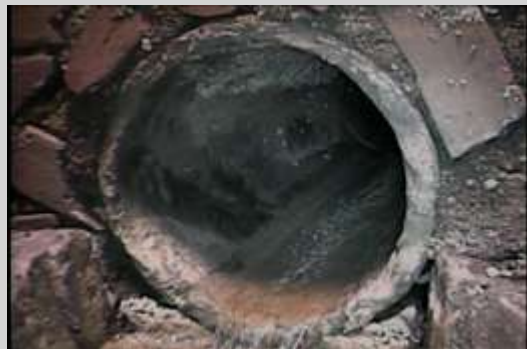
Pipe In @ 9 O'Clock

Barrel deterioration and infiltration.

Infiltration: **Evidence**

Pipe Seal Cond: **Broken**
